**PECULIARITIES OF CORROSION OF THE EQUIPMENT OF THE
SYSTEM OF PURIFICATION OF HYDROCARBON GASES FROM
ACIDIC COMPONENTS**

Murodov Malik Negmurodovich

Rayimov Zukhriddin Khayriddin ogli

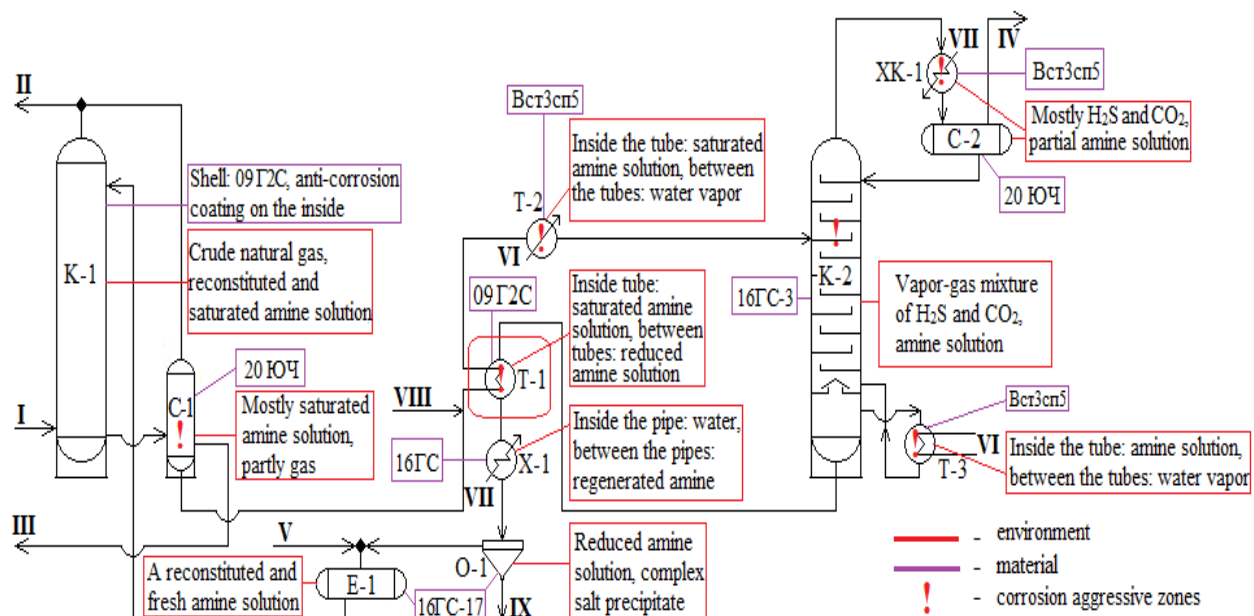
Figure 1. Calculation of corrosion-aggressive zones of an amine purification plant for hydrocarbon gases and the selection of proposed corrosion-resistant materials.

I-gas for cleaning; II-purified gas; III-hydrocarbon condensate; IV- H₂S; V-methyldiethanolamine solution; VI pairs; VII-water; VIII-inhibitor; IX - complex salt precipitate.

In addition to general corrosion, pressure equipment and plant equipment are susceptible to various types of localized corrosion, including stress corrosion cracking and pitting corrosion (Figure 1).

The K-1 absorber is made of 09G2C steel. The inner surface of the device is covered with a 2-3mm thick corrosion-resistant material, which protects the shell made of 09G2S steel from the aggressive environment. Therefore, despite the fact that the environment in the K-1 absorber is very aggressive (H₂S, CO₂, CH₄, H₂O and MDEA), the corrosion process is relatively slow. However, in layers coated with anti-corrosion material and in welded seams of columns, tanks and condensation-cooling equipment, as a result of corrosion erosion, cracks are formed that spread to the surface of the base metal - carbon steel (the base metal does not “temporarily” weather)[3].

The separation of natural gas released from the bottom of the K-1 absorber and added to the saturated amine solution is carried out in the C-1 separator. Separator S-1 is made of steel 20YCh.

The saturated amine solution removed from the bottom of separator C-1 is heated by the heat of the reduced amine solution in heat exchanger T-1[4].

The T-1 heat exchanger is made of 09G2S steel. Contains 0.09% carbon, 2% manganese, up to 1% silicon and about 2.5% other additives. The most aggressive corrosive zone of the installation for amine purification of hydrocarbon gases is the T-1 heat exchanger, and the most vulnerable part of the installation to corrosion is the tube bundles. Their service life is 1.5-3 years, depending on the type of aggressive environment and temperature. The saturated amine solution removed from the T-1 heat exchanger is fed into the K-2 desorber at a temperature of 80 °C. This device is made of steel 16GS-3 with a carbon content of 0.12-0.18%, silicon 0.4-0.7%, manganese 0.9-1.2%, containing up to 0.3% nickel, sulfur up to 0.04%, phosphorus up to 0.035% . , up to 0.3% chromium, up to 0.008% nitrogen, up to 0.3% copper, up to 0.08% arsenic and 97% iron. The reason for the corrosion process in the upper part of the desorber is explained by the high concentration of H₂S and CO₂. The corrosion process in the lower part of the stripping device, where the nozzles are located, proceeds faster than in the upper part of the device. The reason for this is due to exposure to high temperature and direct current[5].

The inhibitor is introduced into the system perpendicular to the MDEA-saturated pipe entering the T-1 heat exchanger. The high concentration of corrosion inhibitor in the T-1 heat exchanger blocks the corrosion process due to the formation of a complex compound with the metal surface in the corrosion-active zones of the device. The effect of direct current in the tubes of the T-1 heat exchanger causes the formation of a layer of complex compound formed by the metal surface over a certain period of time. In this case, instead of the migrated layer, the corrosion inhibitor constantly added to the medium creates a new layer. Extraction of the remains of the migrated layer containing complex salts is carried out in an O-1 quencher. The remnants of the migrated layer containing complex salts are removed from the tapered lower part of the O-1 clarifier, and the reduced amine solution, cleared of residues, is removed from the upper part.

The recovered amine solution is mixed with a new amine solution in container E-1 and sent to the absorption column. The purified gas is removed from the upper part of the absorber.

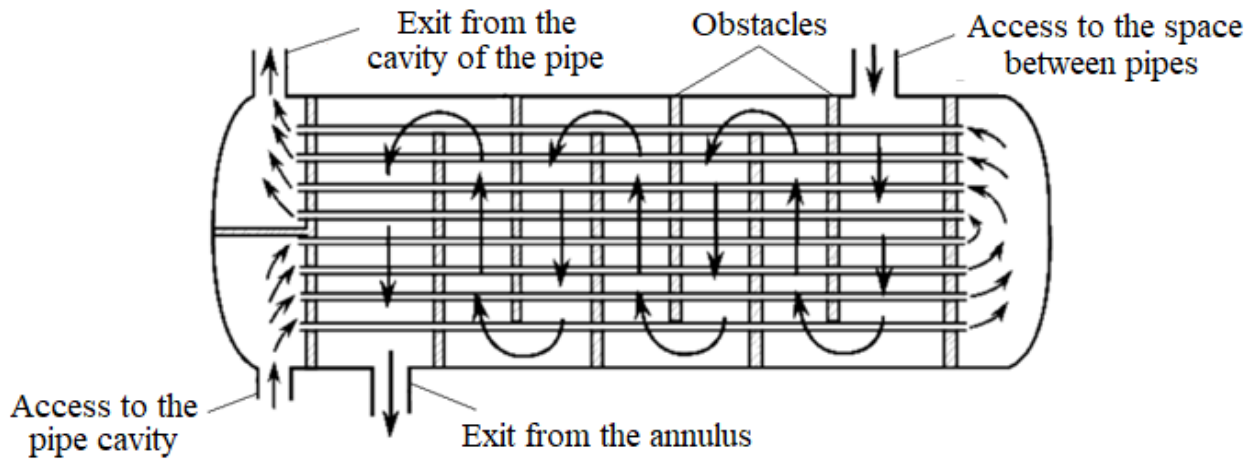
In industry, shell-and-tube heat exchangers are used to transfer heat from one fluid to another. In this case, one of the liquids heats up and the other cools. The structure of the device is shown in Fig. 2. The device mainly consists of a housing and a set of tubes inside it.

Figure 2. The principle of operation of the shell-and-tube heat exchanger

The reasons for the decrease in the capacity of the shell-and-tube heat exchanger are the accumulation of foam, oil, salts and tars on the heat exchange surface of the pipes, as well as metal corrosion.

Performance characteristics of the studied heat exchanger:

- environmental parameters inside the pipes: saturated amine solution, $T = 50...80^{\circ}\text{C}$; $P=490\text{ kPa}$
- pipe size and material: $\varnothing 20 \times 2.0\text{ mm}$, steel 09G2S;
- parameters of the environment between the pipes: the recovered amine solution, $T=118...83^{\circ}\text{C}$; $P=910\text{ kPa}$
- pipe grid -12X18N10T;
- corrosion allowance: 3 mm.

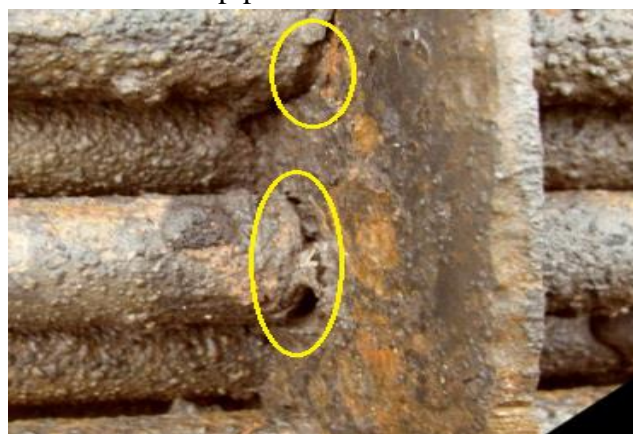
The most rapidly corroding part of the shell-and-tube heat exchanger is the tube set. Barriers are installed in order to make the device multi-way in the space between the pipes. Corrosion is observed at the junctions of pipes with barriers and pipe networks.

Figure 3. Corrosion of connections between pipes, piping network and barriers

1. Corrosion of the connections between the network of pipes and barriers (Fig. 3)
2. Corrosion-erosive damage of the inner surface of the inlet and outlet nozzles of the heat exchanger
3. At first, uniform, uneven, pitting corrosion along the entire length of the heat exchange pipe (Fig. 4)
